Technical Memorandum

Vegetation Management Weed Mat Trial

January 2008

California Department of Transportation

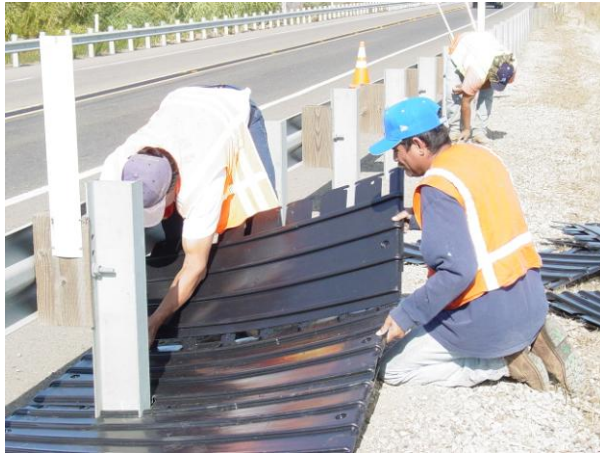
Installation process connecting panels

However, the process of attaching the panels together went well and they were easy to adjust around the guardrails and lock into place. Once the panels were installed, they tended to shift around too much and had serious warping problems. At that time, per the manufacturer's direction, we attached the additional new

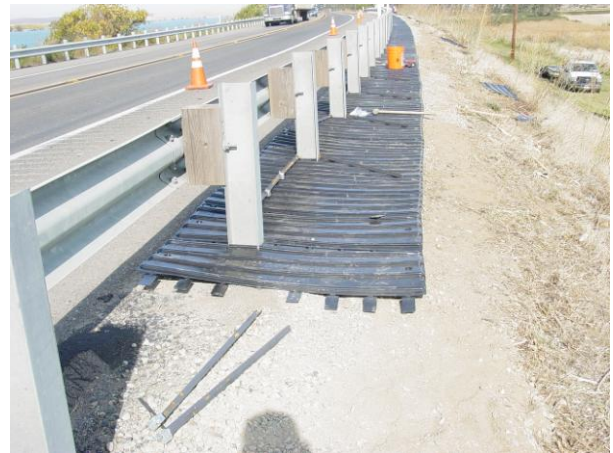
Panels warping in the sun

Universal Weed Cover vegetation weed mat installation went poorly. The brochure installation instructions were inadequate and ridged plastic panels were warping the first day at the site due to the heat. The plastic panels warped in both directions causing large gaps between the asphalt road edge and the panels.

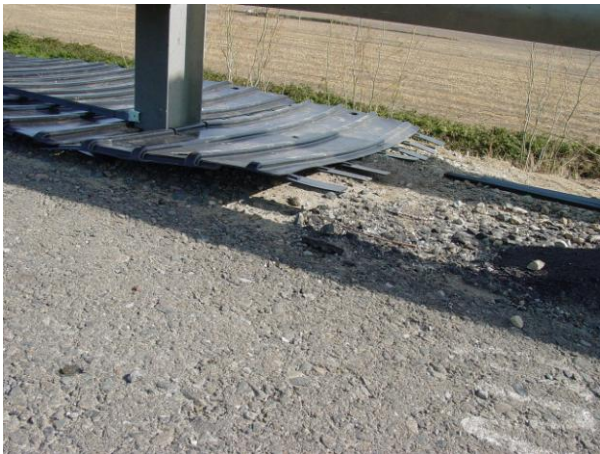
Panels warping along the road edge

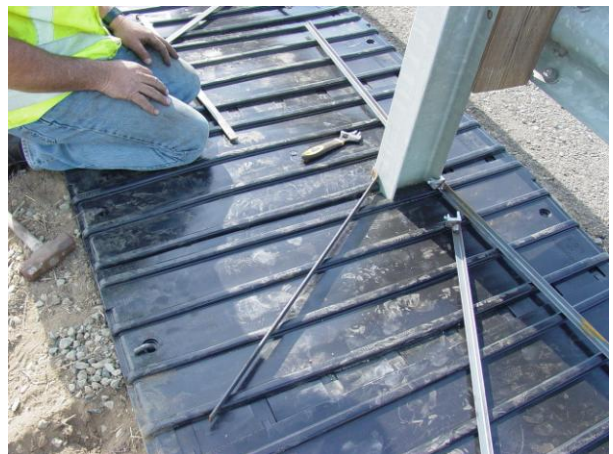
Defective support brackets

metal brackets that were supposed to secure the panels to the ground and prevent the panels from warping. These new metal brackets had several problems and were unsafe. The metal brackets were comprised of a pot metal "C" clamp welded to an angle iron about 30" long. The weld between these two different types of metals did not hold and several of the metal brackets broke apart during initial installation. Furthermore, the metal brackets that were installed failed to hold the plastic panels to the ground and did not prevent warping. Once a large enough section was installed, the Caltrans representative was notified to review the installation.

During the review of the initial installation, the Caltrans representatives determined that the additional securing brackets were unsafe and ordered us to immediately remove them. The Caltrans representative instructed crews to find another way to secure the panels or to remove the panels all together. At that time, another method was selected to secure the panels. Panels were drilled with ½” holes along the roadway shoulder and secured with ½” by 8” long lag bolts to hold the panels together and attached them securely to the roadway shoulder surface. In addition, lag bolts ½” by 10” long were added to the back of these panels to alleviate the panel from warping and secured them to the ground. This method was slow and time consuming but worked well and made the installation acceptable to Caltrans representative. This product as installed with additional securing has a good possibility of providing long-term weed control.

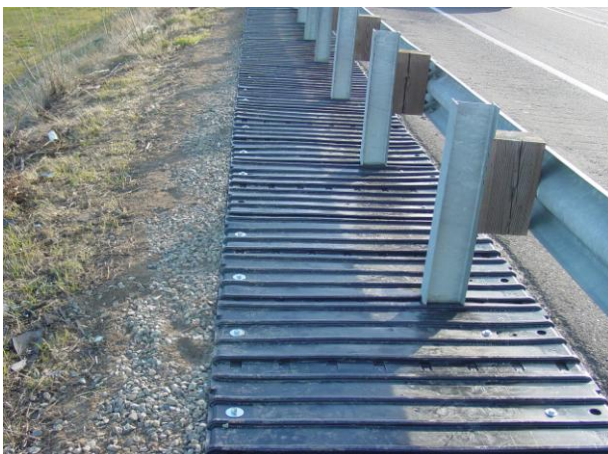
Revised installation using anchor bolts

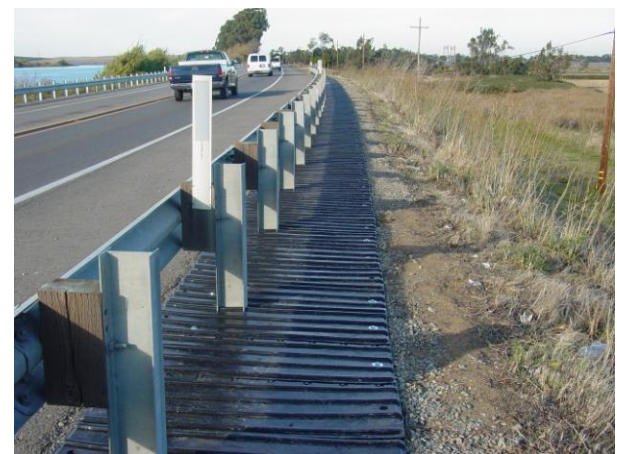
Revised installation site overview

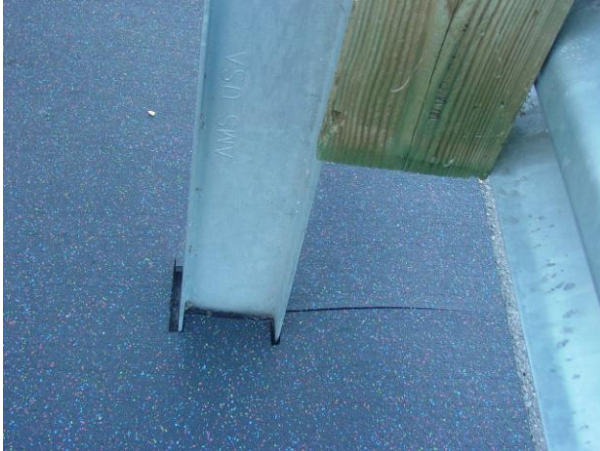
Weed mat cut-out at guardrail post

U.S. Rubber vegetation weed mat installation went well. The large 100 foot rolls were cut into 50 foot sections and rolled into place. Workers used razor knives to cut the material into place and formed it around guardrail posts. Rolls were secured together with a small six inch wide strip of rubber mat under each seam and applying Henry’s 104 asphalt adhesive and bolting the seam together. This worked relatively well except that the recommended Henry’s adhesive does not harden with enough adhesive strength to hold the seam together. Installation of additional bolts at the seams worked well but another product needs to be used to better hold the material together at the seams. In addition, the Henry’s 104 asphalt adhesive was added around the guardrail I-beams to prevent weed growth. This installation went much smoother, but the material was a little too light and rippled along the roadway and shoulder. It was then suggested by a Caltrans representative to add additional securing using the lag bolts concept as used on the Universal Weed Mat product. At that time additional securing was added and the product installation was complete. Once complete, the product installation looked good and was acceptable by the Caltrans representative. This product as installed has a good possibility of providing good long-term weed control.

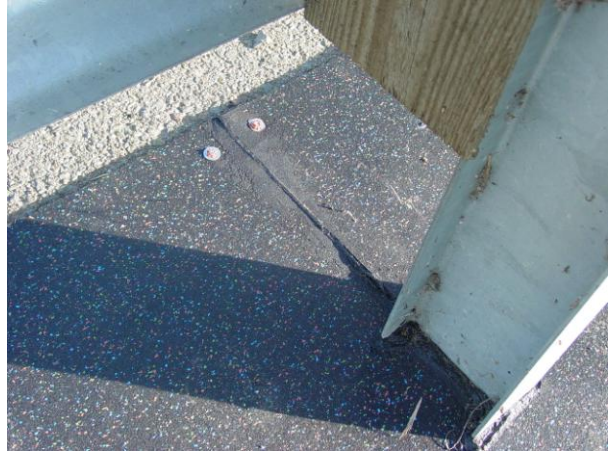
Finished weed mat surface at guardrail post

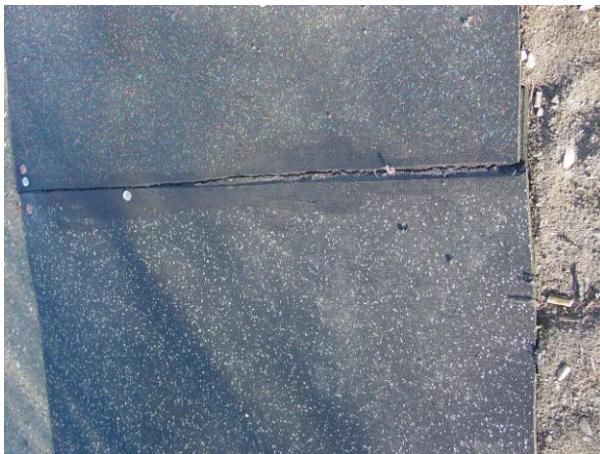
Weed mat seam

The overall installation remained intact and product was secure with no signs of becoming loose. The product also showed no signs of wear and seemed to control weed growth along the roadside. However, the product did have signs of buckling at the seams because the Henry's 104 adhesive did not adhere as anticipated. However, bolts added at the seams still secured the seams together and should not cause any future problems.

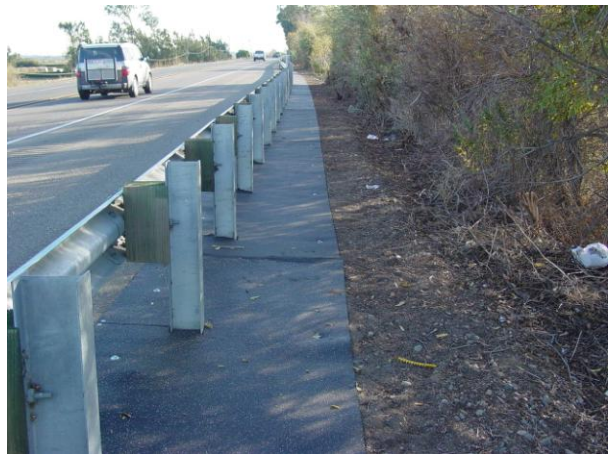
Weed mat site overview

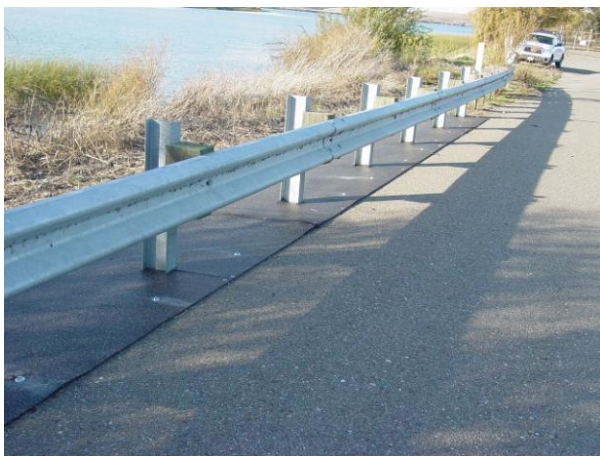
Weed mat at road edge

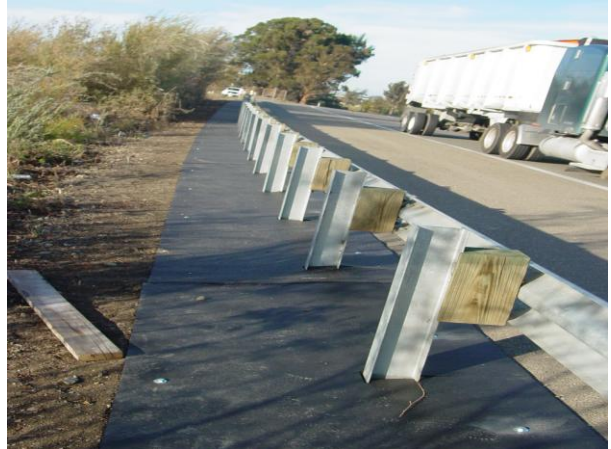
Weed mat at shoulder
